PROPERTY INSPECTION REPORT

Prepared For: John & Jill Doe
(Name of Client)

Concerning: 123 Sample Street, Dallas, TX 75000
(Address or Other Identification of Inspected Property)

By: Jay Wilkinson, Lic #TREC #20338 01/01/2019
(Name and License Number of Inspector) (Date)

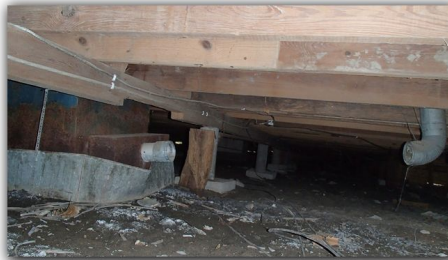
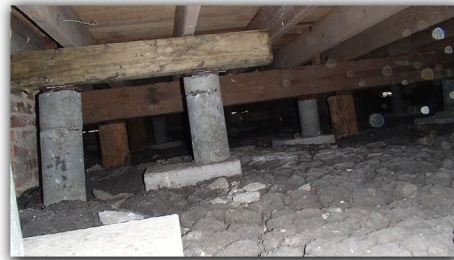
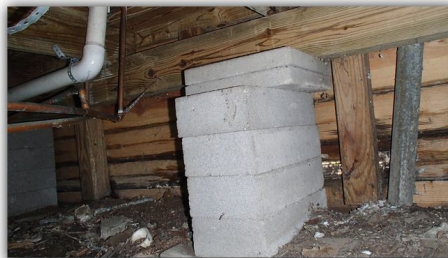
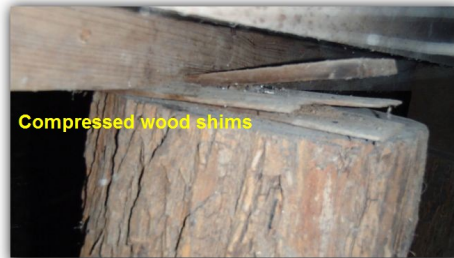
Crawlspace views:

The crawlspace was entered and inspected. Some of the pier and beam foundation structural components appear to have deficiencies that are considered to be normal and average for age. It is common to see signs of seasonal movement throughout the structure like doors that bind or do not latch, uneven floors, and minor interior and exterior surface cracks. There were a number of shifted piers and in at least one instance, there was a pier that was not touching the beam and that beam was beginning to twist or rotate. Further evaluation by a foundation company is recommended to determine what repairs and adjustments are needed.

You should be aware that there is visible evidence of previous foundation repairs. You are encouraged to consult the current homeowner concerning the scope of previous foundation work performed and any warranty information that may be available. Determining the effectiveness of previous foundation repairs is beyond the scope of a limited visual inspection.

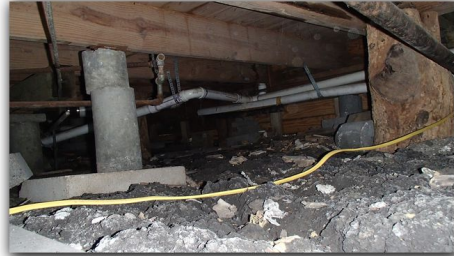
One or more of the piers have shifted somewhat, as is typical of many houses due to expansive soils in the North Texas area. These should be monitored periodically.

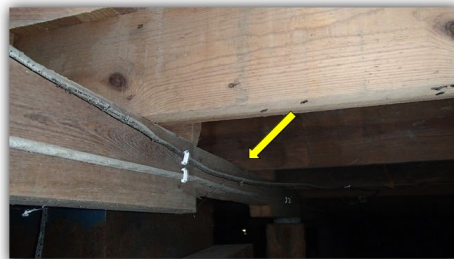
One or more of the piers were not touching the beam or floor joist. Shimming or other repairs are recommended.

One or more of the wood beams were twisting or rotating in the crawlspace.

One or more joists or beams were notched in the crawlspace. If notching is done improperly it can reduce the altered joist or beam's structural strength. Monitoring is recommended.

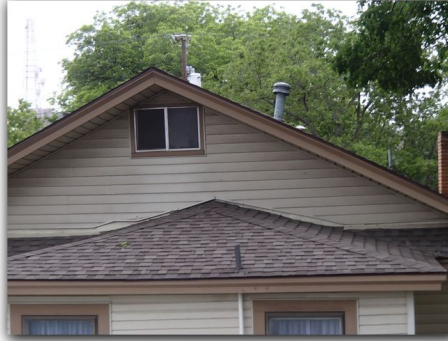
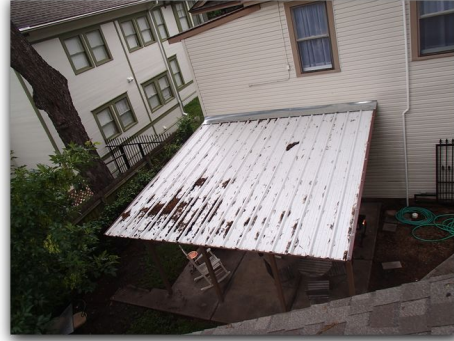
Roof views:

In my opinion, the roof is functioning as intended and shows average wear for age. All components were found to be in satisfactory condition on the day of the inspection except as noted below:

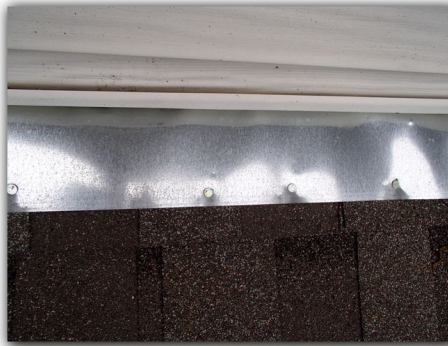
Roof fasteners (nails and/or staples) were observed to be exposed on various locations of the roof including the ridge caps and flashing areas. All exposed fasteners should be sealed with the appropriate roofing caulk or sealant.

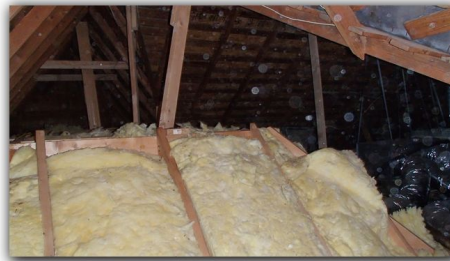
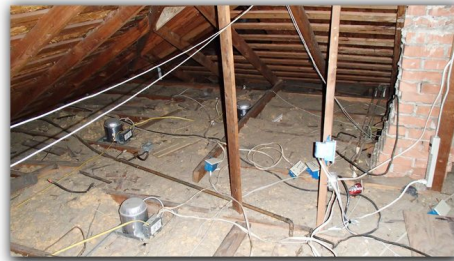
Attic views:

The insulation was inadequate. Adding insulation to a minimum depth of nine inches is recommended.

The ventilation in the attic appeared to be inadequate. Repair is recommended.

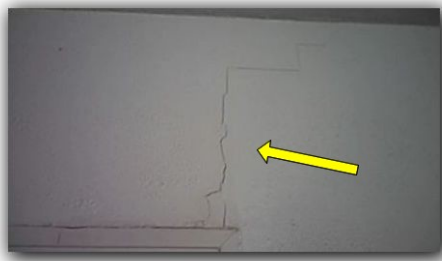
There are minor cracks in the interior walls that are considered to be cosmetic and average for age. No attempt is made to discover or document an exhaustive list of every crack or anomaly. These deficiencies should be repaired when repainting the interior.

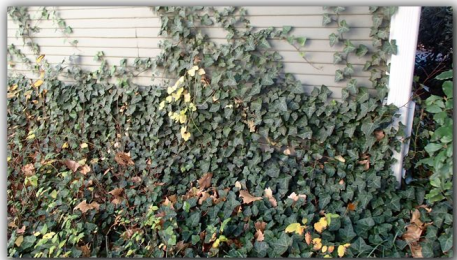
Note: The heavy foliage growing on, over or around the exterior walls of the structure should be trimmed back at least 18-inches. The heavy foliage will limit the Inspectors visual observation of the exterior surfaces.

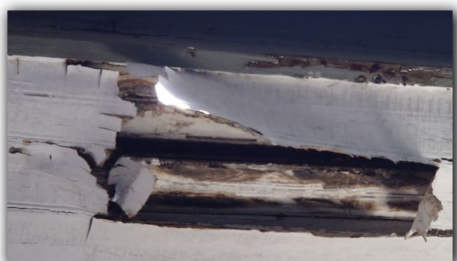
The wood siding and wooden supports were making wood to ground contact by design. This condition may promote wood rot and may attract wood destroying insects. These areas should be monitored and corrective measures taken it necessary.

The soffit was observed to be deteriorated or damaged at the south side of the house. Repair is recommended.

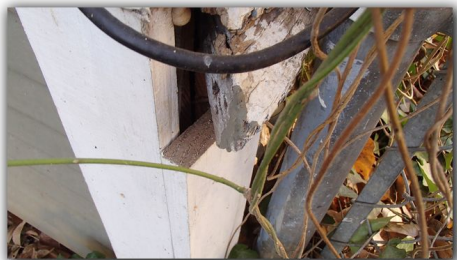
The wood siding and trim was observed to be damaged or deteriorated at the north, east, west, and south sides of the house, particularly along the lower edges of the siding. Repair is recommended.

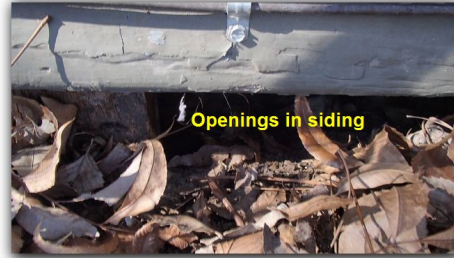
There were openings in the exterior veneer in various locations including at the north and east sides of the house that need to be sealed to prevent water or pest intrusion into the crawlspace.

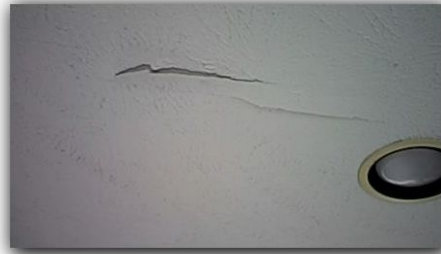
Ceiling texture was observed to be damaged in the carport. Repair is recommended.

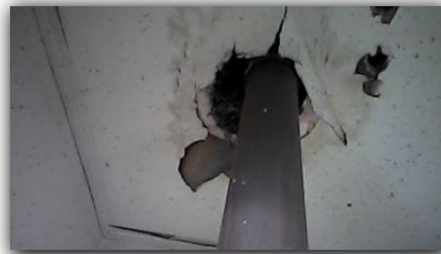
Water stains were observed at or around the water heater flue in the garage. The cause and remedy should be further evaluated and corrected as necessary.

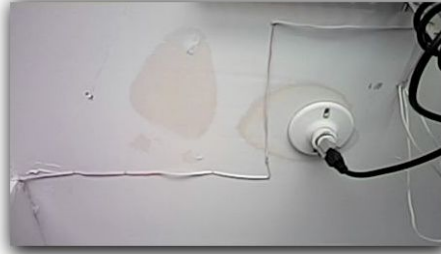
Water stains were observed on the ceiling finish in the garage in the northeast corner bedroom. The cause and remedy should be further evaluated and corrected as necessary.

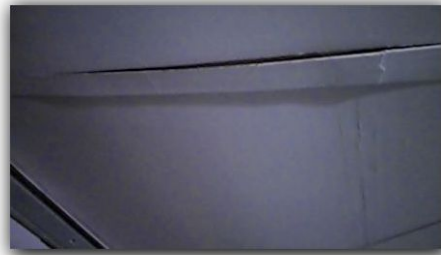
The ceiling of the attached garage adjacent to the living space was not fire taped at the joints or the fire taping is damaged or failing. Drywall cladding on garage ceilings and walls that are adjacent or common with the living space should have the joints taped and sealed to provide the required fire rating for attached garages.

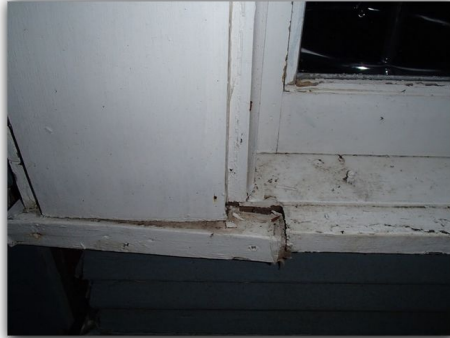
The trim was observed to be damaged or deteriorated on the windows at the north side of the house. Repair is recommended.

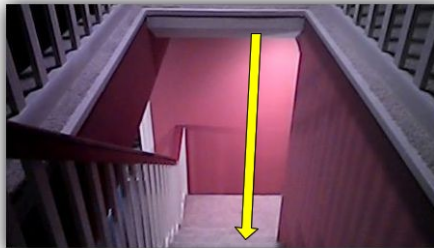
Ceiling height was observed to be insufficient at the middle landing of the staircase. If reconfiguration is impractical, care should be taken when using the stairs.

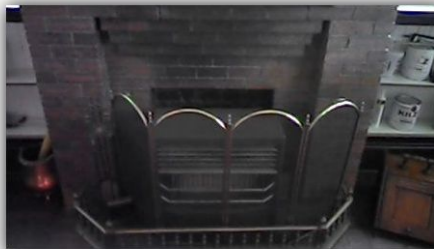
Type and location: Decorative fireplace only, in the living room

The fireplace was decorative only, not intended for use as a wood burning fireplace without repair.

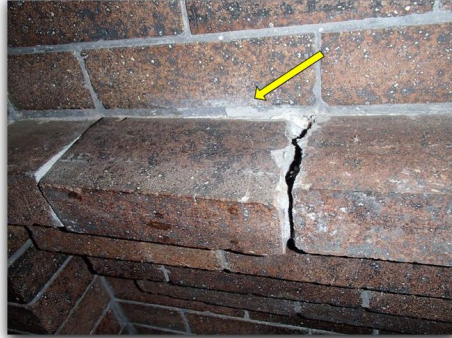
The façade and mantle area of the fireplace was damaged. Repair is recommended.

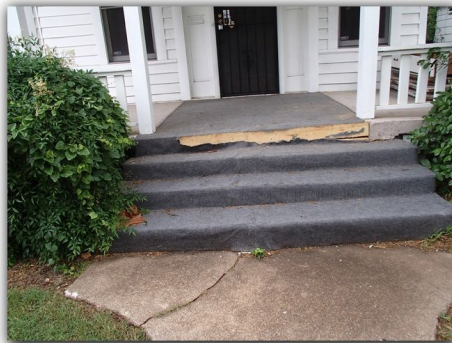
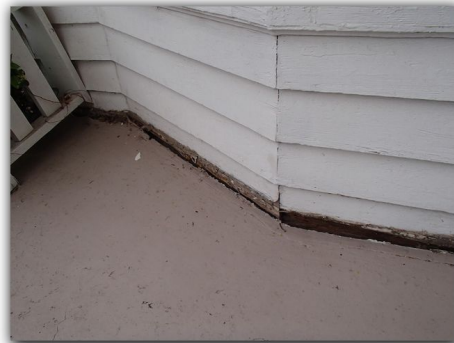
The porch or patio was settled at the east side of the house. Monitoring and repair is recommended as needed.

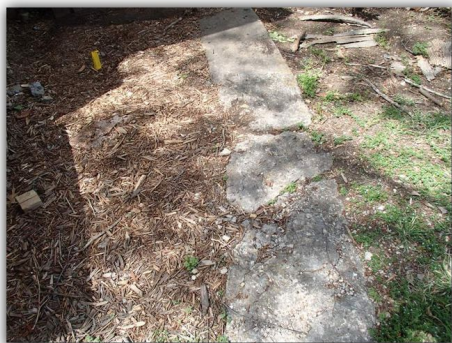
The walkway at the northeast corner of the house was cracked, damaged, or deteriorated. Improvements should be considered.

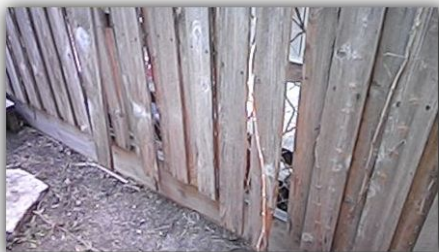
The wood fence was weathered and had numerous loose panels and fence boards.

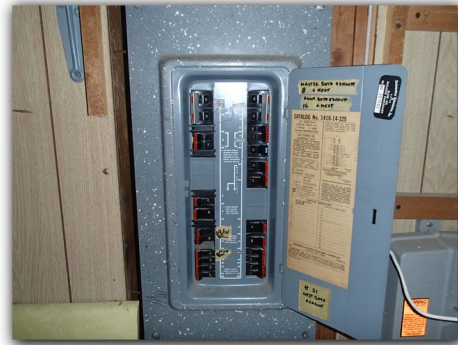
There is a Federal Pacific panel box in place at the time of the inspection. Due to the age of the panel box and the problems associated with this type of panel box, upgrading this panel box with a more current panel box is recommended. Full evaluation of this panel box is beyond the scope of this inspection. You are encouraged to have the panel box further evaluated by a qualified electrician prior to closing.

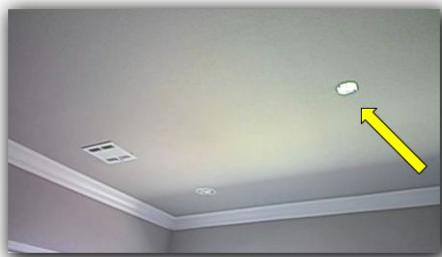
Ceiling fan or light fixture was not installed in the formal living room.

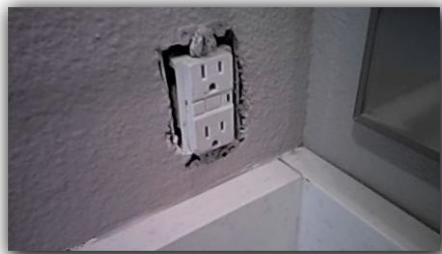
One or more of the light fixtures appear to be inoperative in the formal living room at the west side of the house. This may be due to a bad bulb or some other unknown condition. Further evaluation and repair is recommended as needed.

One or more of the receptacles is missing its cover plate in the half bathroom. Replacement of the cover plate is recommended.

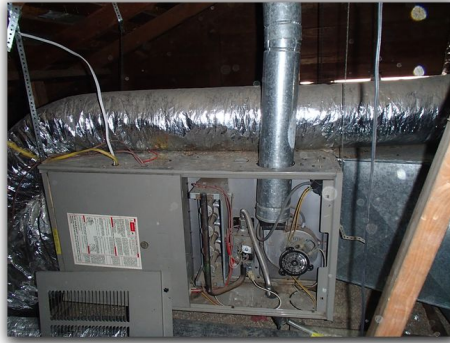
Central Heating System – *Energy Source:* Natural gas, Goodman, 1997

The heating equipment appears to have reached the end of its serviceable life expectancy.

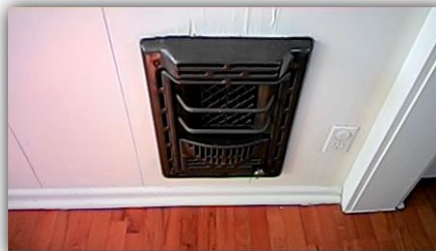
Unvented gas space heaters are present in the mudroom. Due to safety concerns, removal or replacement with a vented heater is recommended.

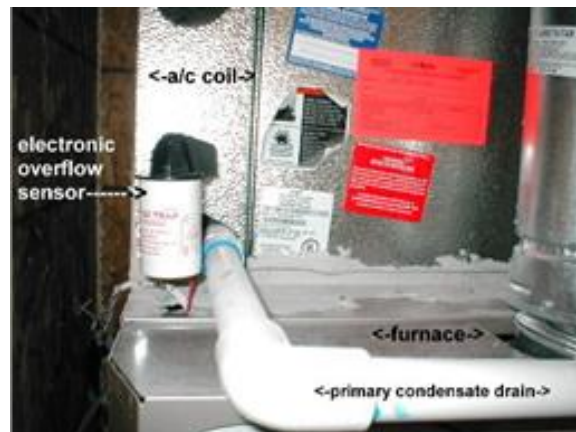
Example photo of an overflow switch

There is no secondary drain for the air conditioning coil. If piping a secondary drain line to the exterior is impractical, installation of a condensate overflow switch or alarm is recommended to avoid damage from obstructed primary condensate lines.

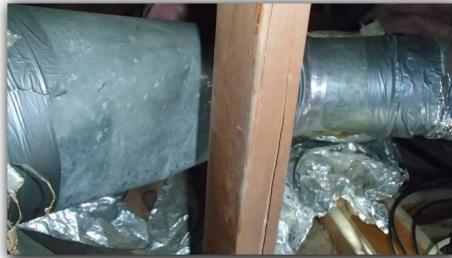
The covering on the ductwork that secures the insulation has deteriorated and the insulation is falling off in places, reducing the HVAC system efficiency. Repair or replacement of the damaged ductwork is recommended.

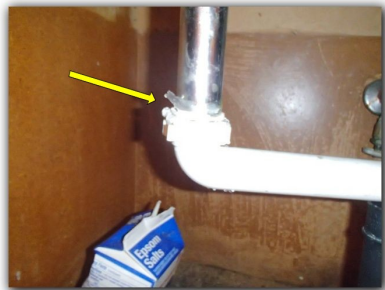
The sink was observed to have a leak at the drain in the kitchen. Repair is recommended.

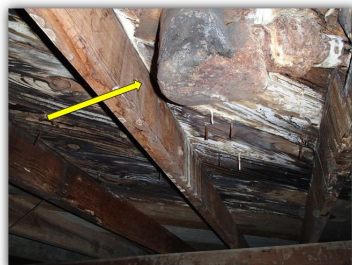
An older lead drum trap was observed under the shower in the hall bathroom. Replacement is recommended.

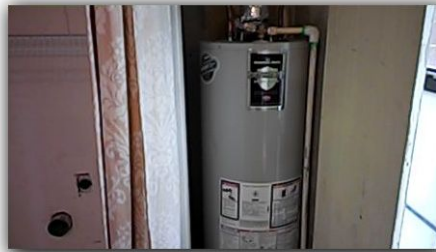
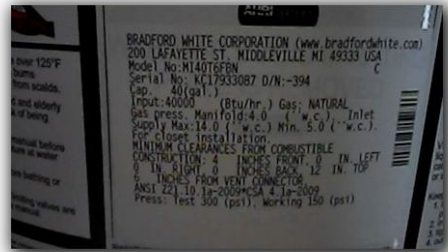
Double Wall B-Vent was not installed correctly.

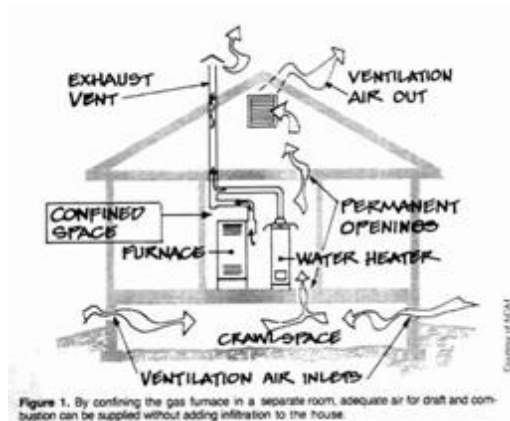
There is inadequate combustion air in the equipment closet. Combustion air for gas equipment should be supplied from an exterior source and not taken from the interior living space. Two metal pipes should be installed in the closet from the attic; one terminates near the ceiling and the other 12" from the floor to supply an outside air source.

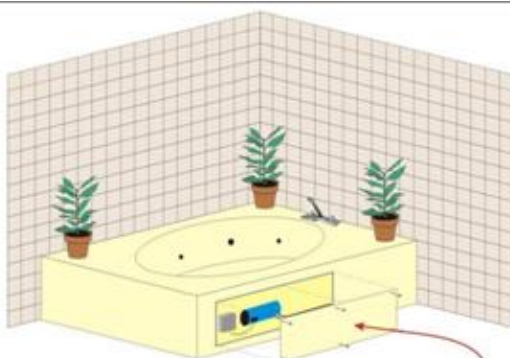
Although there is an access panel at the plumbing connections, the access to the hydro-massage therapy equipment motor and associated plumbing was not readily accessible and could not be visually inspected for proper configuration or leaks. This does not meet current installation standards.

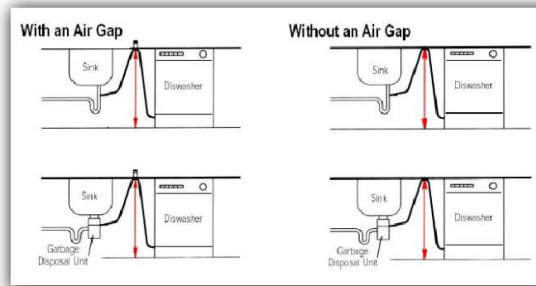
The dishwasher drain hose is not properly installed to prevent back flow or anti-siphoning. It is recommended that an air gap device or high drain loop be installed in the drain line. Note: Some high-end dishwashers may have built in anti-syphon devices.

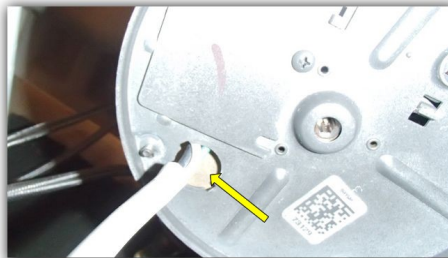
The wiring is poorly secured where it enters the housing. Installation of a wire clamp is recommended.

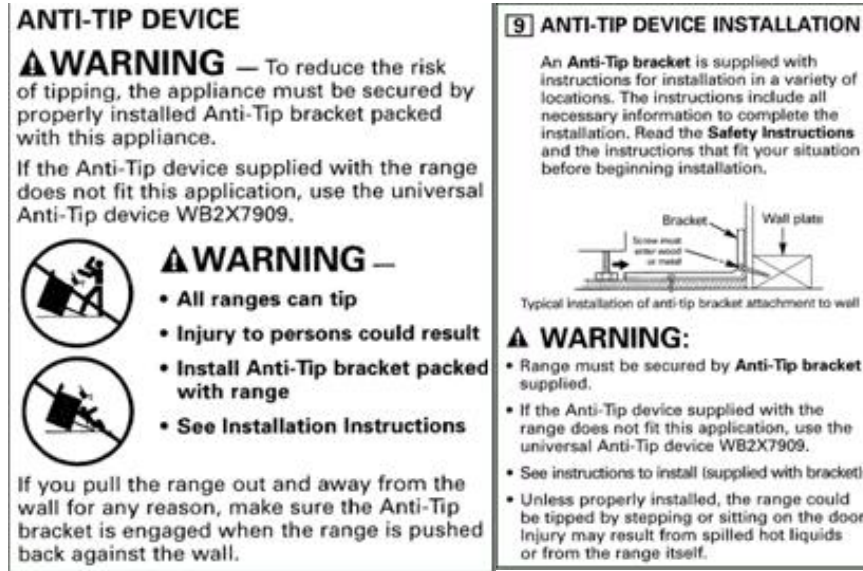
The range can be easily tipped over and should be equipped with an anti-tip device, for safety.

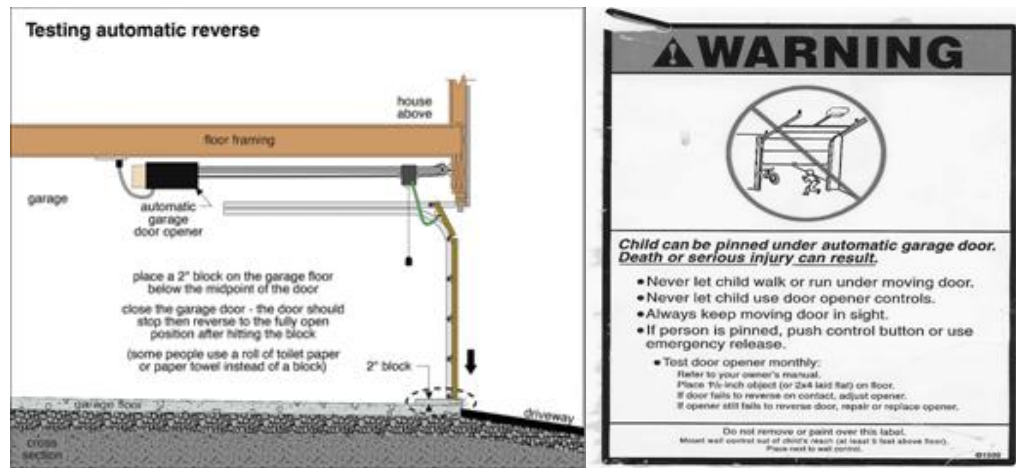
The garage door opener DID NOT automatically reverse under reasonable resistance when closing. Improvement may be as simple as adjusting the sensitivity control on the opener.

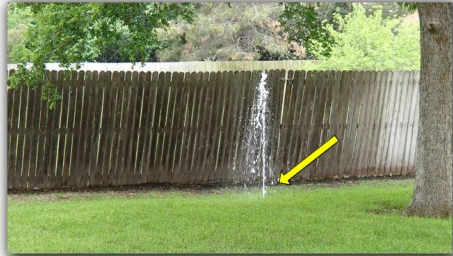
One or more sprinkler heads were damaged or missing in station 4 in the back yard. Repair is recommended.

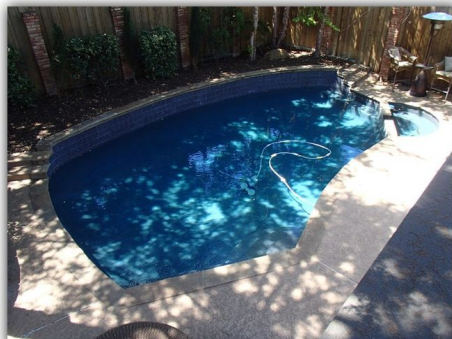
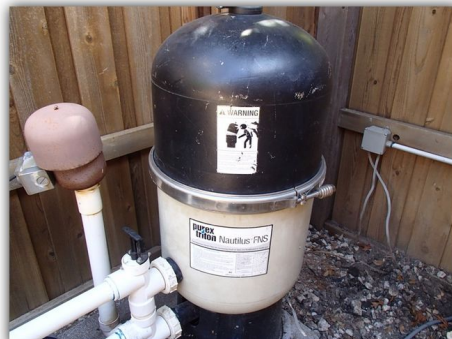
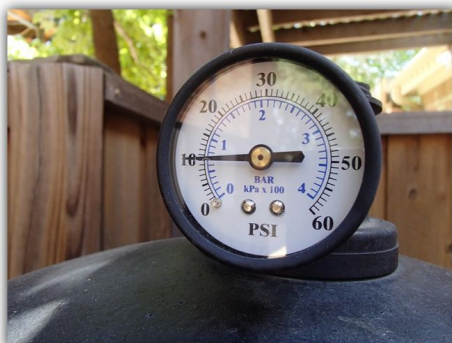
Visible deficiencies were observed in the pool finished surface. Some resurfacing may be necessary. This condition should be further evaluated by a professional pool service.

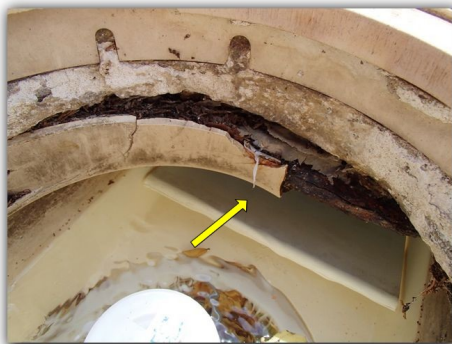
The skimmer basket housing was missing or damaged and needs repair to prevent water intrusion and damage to the decking and pool.

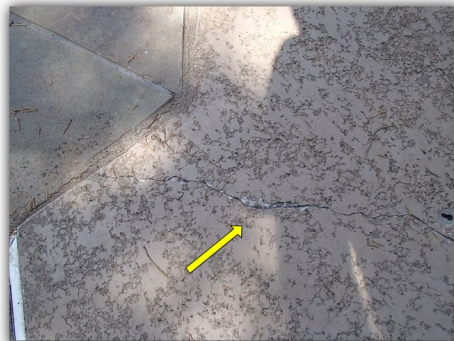
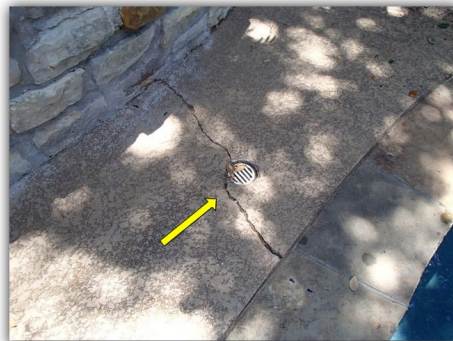
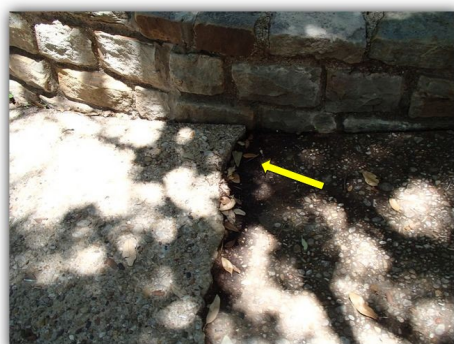
The deck was observed to be cracked or damaged and somewhat settled at the northwest corner of the pool. Repair is recommended.

The elastic caulk (Deck-O-Seal or other brand) between the deck and coping was observed to be in the early stages of cracking. Monitoring is recommended.
