# armor home inspections

**Jill Doe**  
**123 Sample Street**

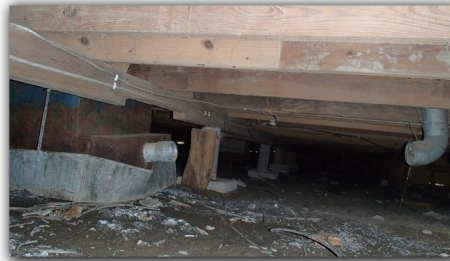
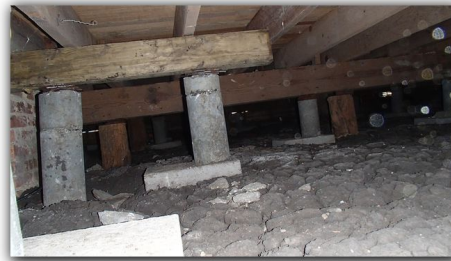
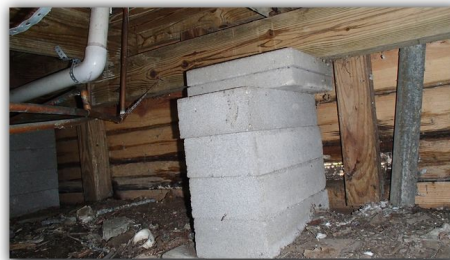
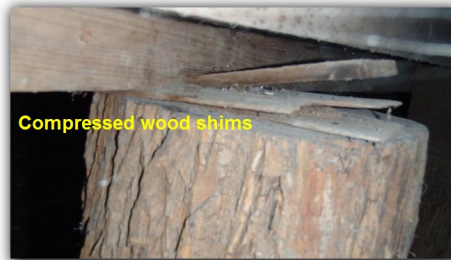
Crawlspace views:

The crawlspace was entered and inspected. Some of the pier and beam foundation structural components appear to have deficiencies that are considered to be normal and average for age. It is common to see signs of seasonal movement throughout the structure like doors that bind or do not latch, uneven floors, and minor interior and exterior surface cracks. There were a number of shifted piers and in at least one instance, there was a pier that was not touching the beam and that beam was beginning to twist or rotate. Further evaluation by a foundation company is recommended to determine what repairs and adjustments are needed.

You should be aware that there is visible evidence of previous foundation repairs. You are encouraged to consult the current homeowner concerning the scope of previous foundation work performed and any warranty information that may be available. Determining the effectiveness of previous foundation repairs is beyond the scope of a limited visual inspection.

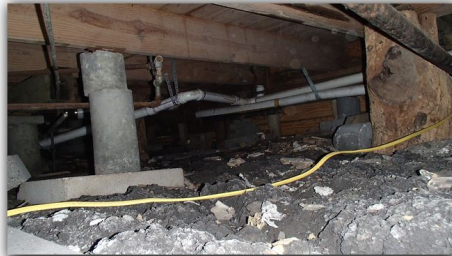
One or more of the piers have shifted somewhat, as is typical of many houses due to expansive soils in the North Texas area. These should be monitored periodically.

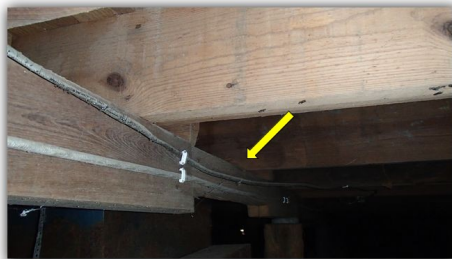
One or more of the piers were not touching the beam or floor joist. Shimming or other repairs are recommended.

One or more of the wood beams were twisting or rotating in the crawlspace.

One or more joists or beams were notched in the crawlspace. If notching is done improperly it can reduce the altered joist or beam's structural strength. Monitoring is recommended.

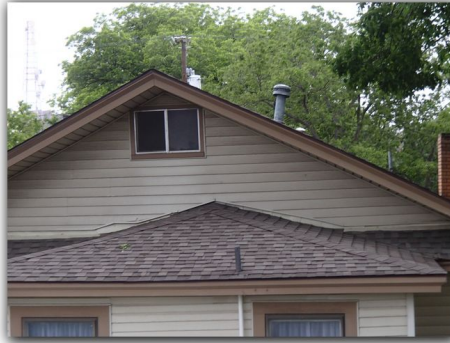
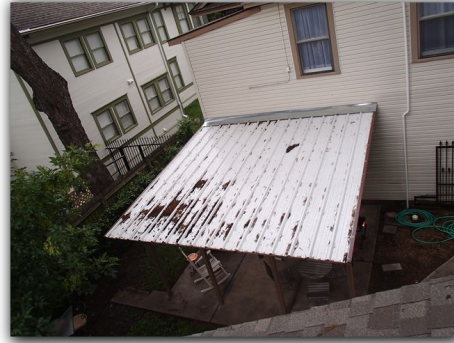
Roof views:

Roof fasteners (nails and/or staples) were observed to be exposed on various locations of the roof including the ridge caps and flashing areas. All exposed fasteners should be sealed with the appropriate roofing caulk or sealant.

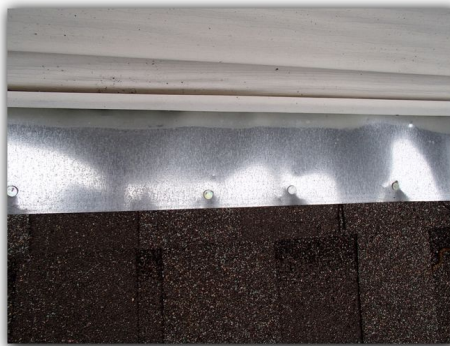
The roofing felt paper was observed to be installed under the lower metal drip edge flashing detail and in some places felt paper did not cover all of the decking. This may allow water to seep behind the fascia board and soffit/eave areas over time. Monitoring is recommended to determine if corrective measures are necessary or cost effective.

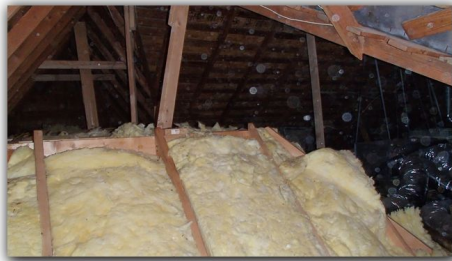
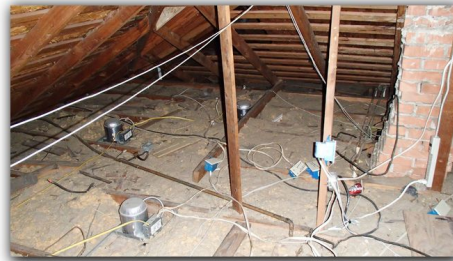
Attic views:

The insulation was inadequate. Adding insulation to a minimum depth of nine inches is recommended.

The ventilation in the attic appeared to be inadequate. Repair is recommended.

One or more areas of the roof structure lack the recommended number of support members (purlins) and some sagging was observed in the rafters and decking. The purlins should be at least the same size as the supported rafter and spaced not more than four feet apart. Adding additional purlins is recommended.

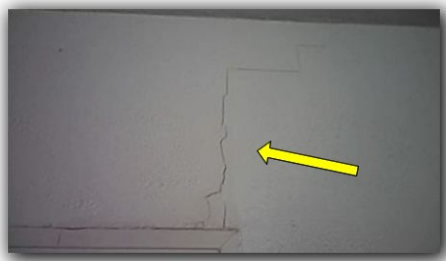
There are minor cracks in the interior walls that are considered to be cosmetic and average for age. No attempt is made to discover or document an exhaustive list of every crack or anomaly. These deficiencies should be repaired when repainting the interior.

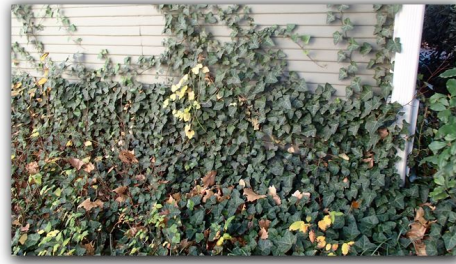
There are minor mortar cracks in the brick cladding or minor cracks from age and weathering in the wood siding that are considered to be cosmetic and average for age. No attempt is made to discover or document an exhaustive list of every crack or anomaly in the exterior. These deficiencies should be repaired to avoid water intrusion.

**Note:** The heavy foliage growing on, over or around the exterior walls of the structure should be trimmed back at least 18-inches. The heavy foliage will limit the Inspectors visual observation of the exterior surfaces.

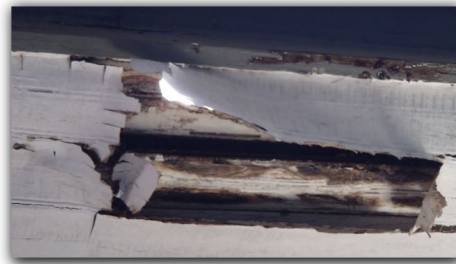
The wood siding and wooden supports were making wood to ground contact by design. This condition may promote wood rot and may attract wood destroying insects. These areas should be monitored and corrective measures taken if necessary.

The soffit was observed to be deteriorated or damaged at the south side of the house. Repair is recommended.

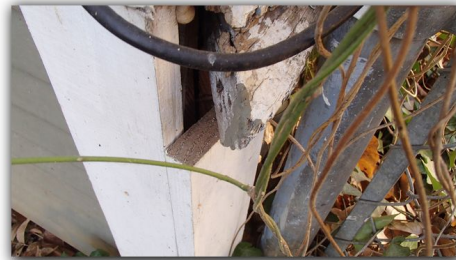
The wood siding and trim was observed to be damaged or deteriorated at the north, east, west, and south sides of the house, particularly along the lower edges of the siding. Repair is recommended.

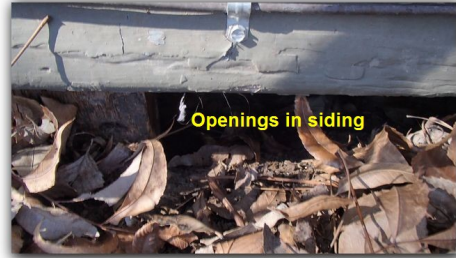
There were openings in the exterior veneer in various locations including at the north and east sides of the house that need to be sealed to prevent water or pest intrusion into the crawlspace.

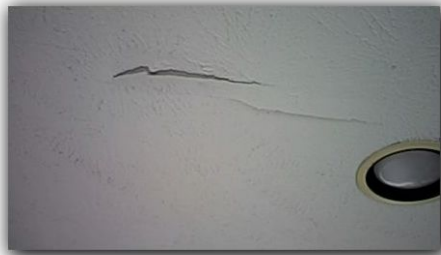
Ceiling texture was observed to be damaged in the carport. Repair is recommended.

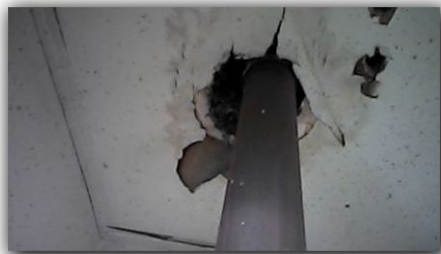
Water stains were observed at or around the water heater flue in the garage. The cause and remedy should be further evaluated and corrected as necessary.

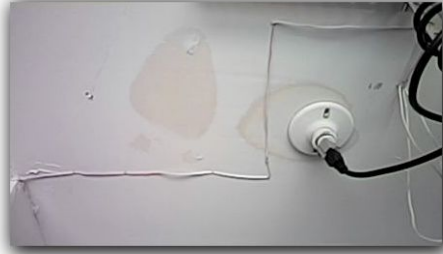
Water stains were observed on the ceiling finish in the garage in the northeast corner bedroom. The cause and remedy should be further evaluated and corrected as necessary.

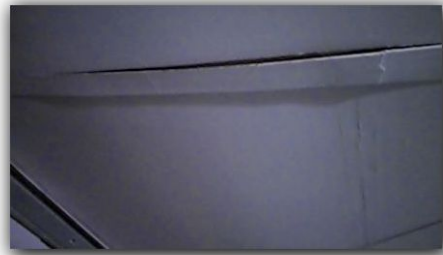
The ceiling of the attached garage adjacent to the living space was not fire taped at the joints or the fire taping is damaged or failing. Drywall cladding on garage ceilings and walls that are adjacent or common with the living space should have the joints taped and sealed to provide the required fire rating for attached garages.

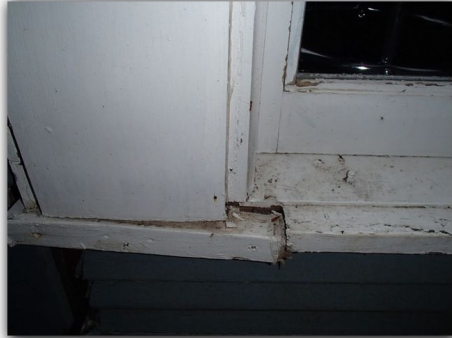
The trim was observed to be damaged or deteriorated on the windows at the north side of the house . Repair is recommended.

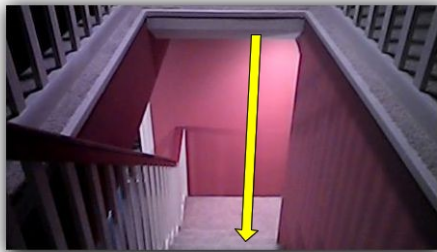
Ceiling height was observed to be insufficient at the middle landing of the staircase. If reconfiguration is impractical, care should be taken when using the stairs.

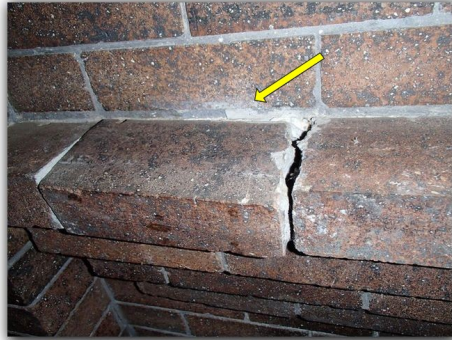
The façade and mantle area of the fireplace was damaged. Repair is recommended.

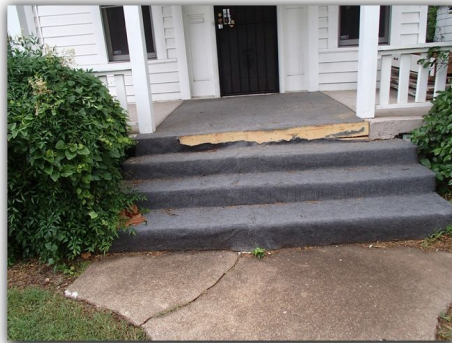
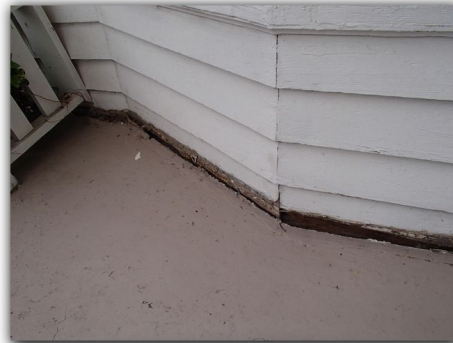
The porch or patio was settled at the east side of the house . Monitoring and repair is recommended as needed.

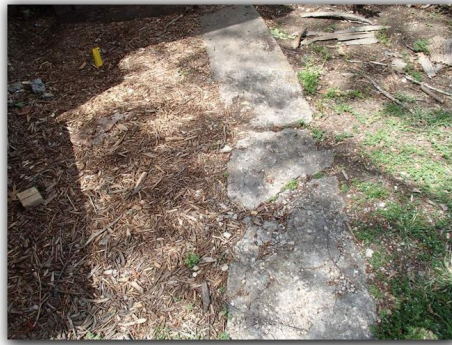
The walkway at the northeast corner of the house was cracked, damaged, or deteriorated. Improvements should be considered.

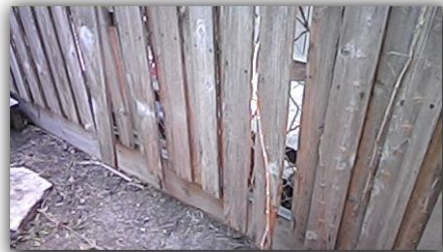
The wood fence was weathered and had numerous loose panels and fence boards.

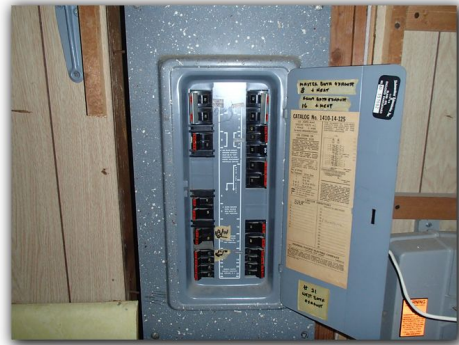
There is a Federal Pacific panel box in place at the time of the inspection. Due to the age of the panel box and the problems associated with this type of panel box, upgrading this panel box with a more current panel box is recommended. Full evaluation of this panel box is beyond the scope of this inspection. You are encouraged to have the panel box further evaluated by a qualified electrician prior to closing.

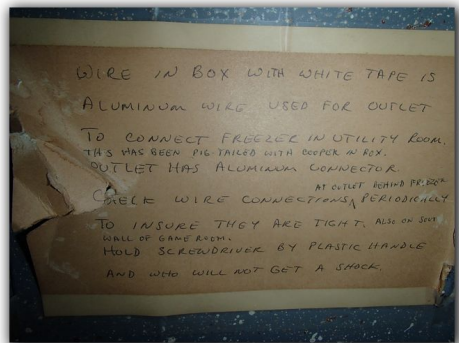
One aluminum wire circuit was present. Aluminum wiring requires special connectors. A note was present on the panel box cover stating that the appropriate connectors were in use, but this could not be verified. If concerns exist, further evaluation by a licensed electrician is recommended.

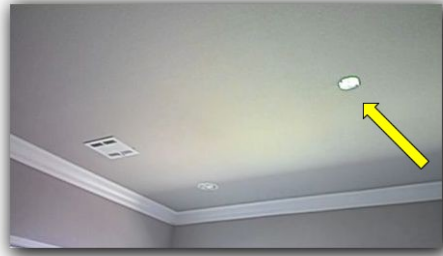
Ceiling fan or light fixture was not installed in the formal living room.

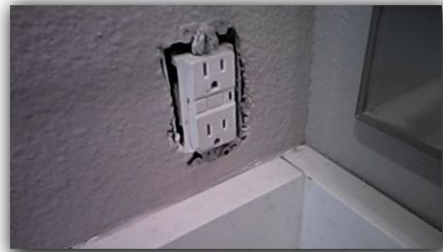
One or more of the receptacles is missing its cover plate in the half bathroom. Replacement of the cover plate is recommended.

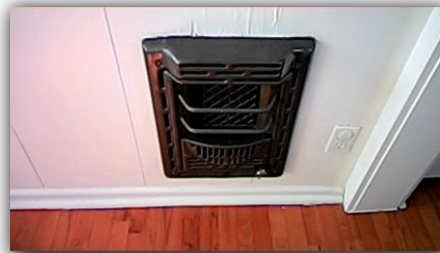
Unvented gas space heaters are present in the mudroom. Due to safety concerns, removal or replacement with a vented heater is recommended.

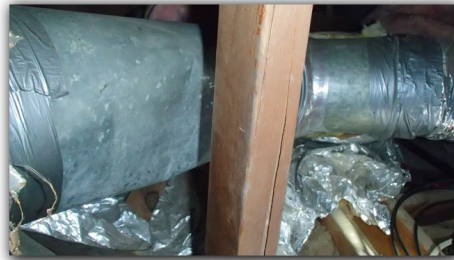
The covering on the ductwork that secures the insulation has deteriorated and the insulation is falling off in places, reducing the HVAC system efficiency. Repair or replacement of the damaged ductwork is recommended.

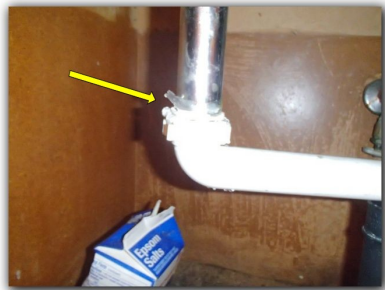
The sink was observed to have a leak at the drain in the kitchen . Repair is recommended.

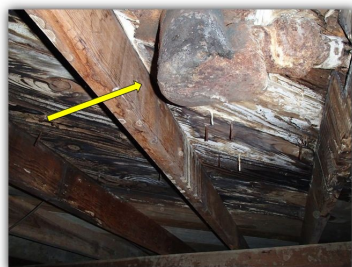
An older lead drum trap was observed under the shower in the hall bathroom. Replacement is recommended.

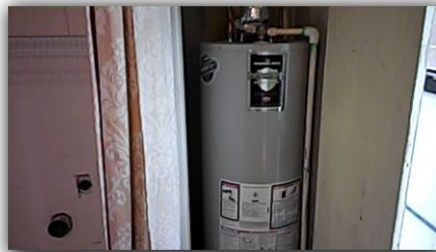
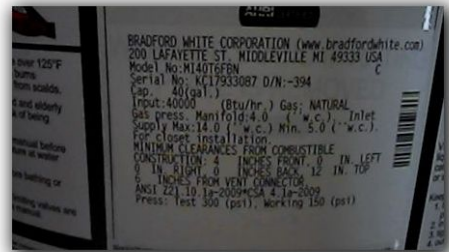
*Double Wall B-Vent was not installed correctly.*

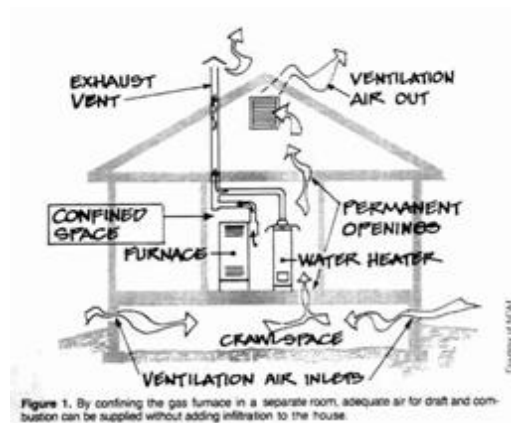
There is inadequate combustion air in the equipment closet. Combustion air for gas equipment should be supplied from an exterior source and not taken from the interior living space. Two metal pipes should be installed in the closet from the attic; one terminates near the ceiling and the other 12” from the floor to supply an outside air source.

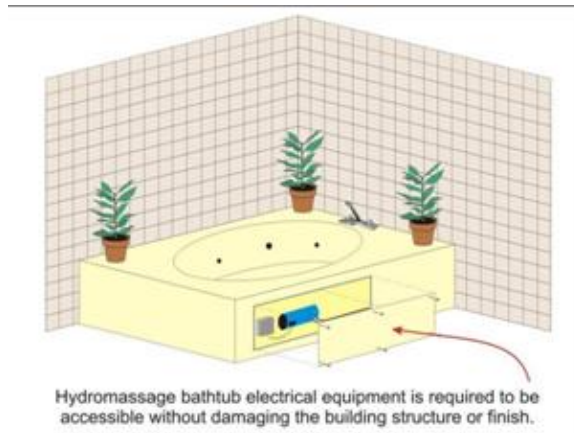
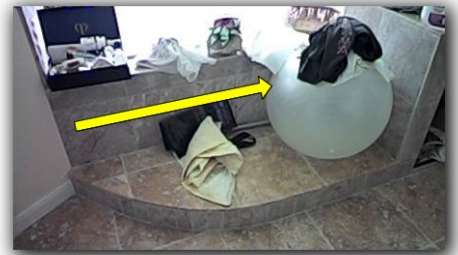
Although there is an access panel at the plumbing connections, the access to the hydro-massage therapy equipment motor and associated plumbing was not readily accessible and could not be visually inspected for proper configuration or leaks. This does not meet current installation standards.

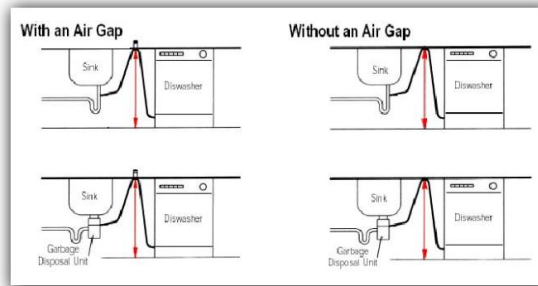
The dishwasher drain hose is not properly installed to prevent back flow or anti-siphoning. It is recommended that an air gap device or high drain loop be installed in the drain line. Note: Some high-end dishwashers may have built in anti-syphon devices.

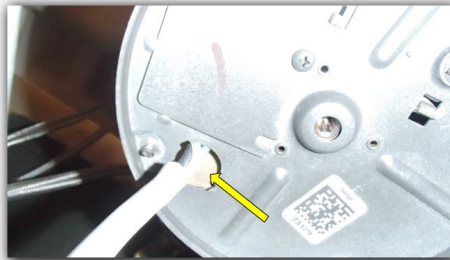
The wiring is poorly secured where it enters the housing. Installation of a wire clamp is recommended.

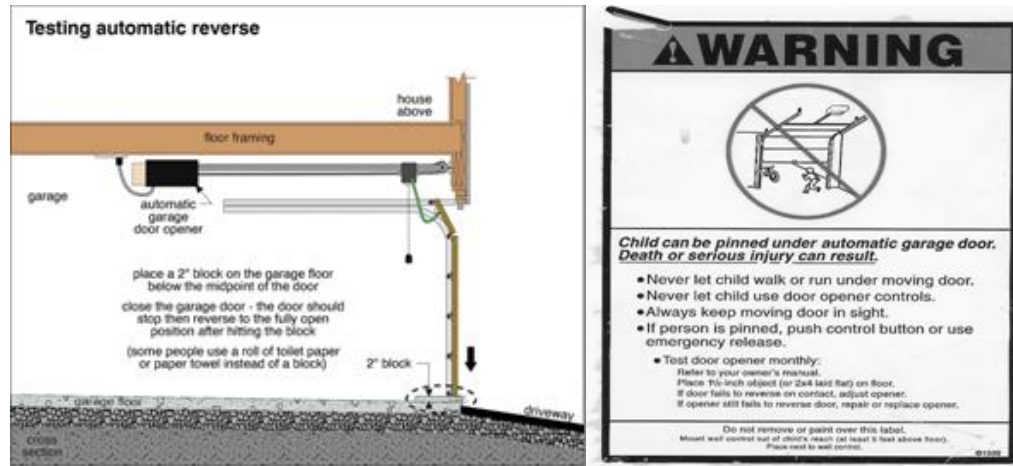
The garage door opener DID NOT automatically reverse under reasonable resistance when closing. Improvement may be as simple as adjusting the sensitivity control on the opener.

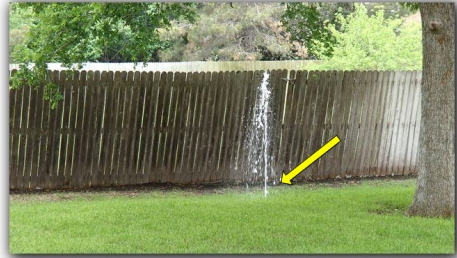
One or more sprinkler heads were damaged or missing in station 4 in the back yard. Repair is recommended.

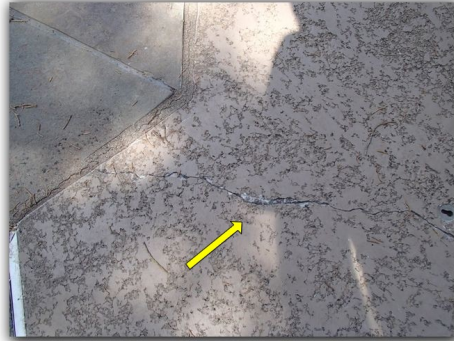
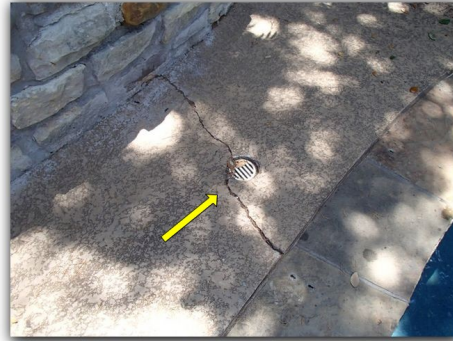
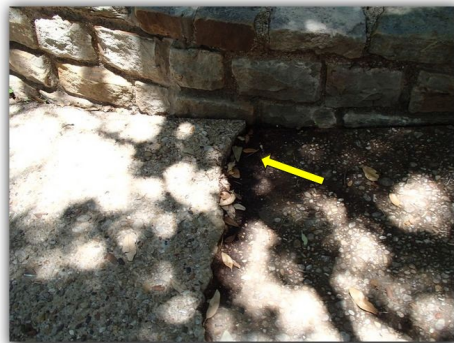
The deck was observed to be cracked or damaged and somewhat settled at the northwest corner of the pool. Repair is recommended.
