armor home inspections

PROPERTY INSPECTION REPORT FORM

Jill Doe <i>Name of Client</i>	04/24/2024 <i>Date of Inspection</i>
1234 Sample Street, Dallas, TX 75111 <i>Address of Inspected Property</i>	
Jay Wilkinson <i>Name of Inspector</i>	TREC #20338 <i>TREC License #20338</i>

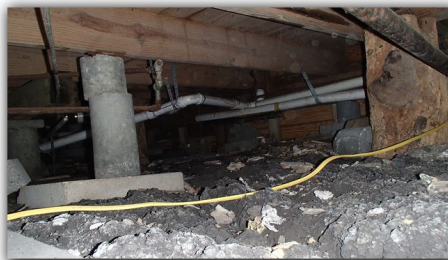
One or more of the piers have shifted somewhat, as is typical of many houses due to expansive soils in the North Texas area. These should be monitored periodically.

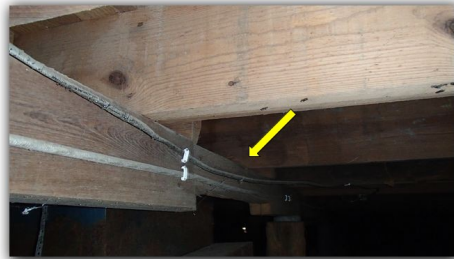
One or more of the piers were not touching the beam or floor joist. Shimming or other repairs are recommended.

One or more of the wood beams were twisting or rotating in the crawlspace.

One or more joists or beams were notched in the crawlspace. If notching is done improperly it can reduce the altered joist or beam's structural strength. Monitoring is recommended.

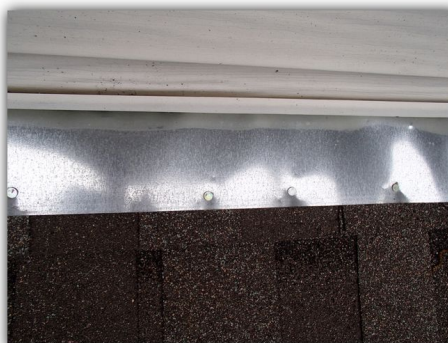
Roof fasteners (nails and/or staples) were observed to be exposed on various locations of the roof including the ridge caps and flashing areas. All exposed fasteners should be sealed with the appropriate roofing caulk or sealant.

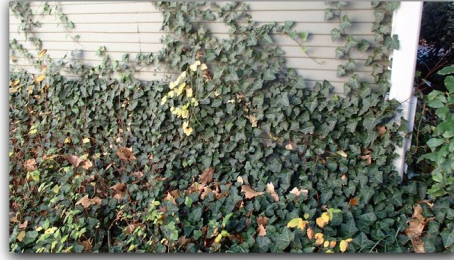
Note: The heavy foliage growing on, over or around the exterior walls of the structure should be trimmed back at least 18-inches. The heavy foliage will limit the Inspectors visual observation of the exterior surfaces.

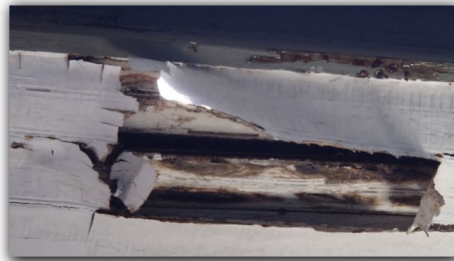
The soffit was observed to be deteriorated or damaged at the south side of the house. Repair is recommended.

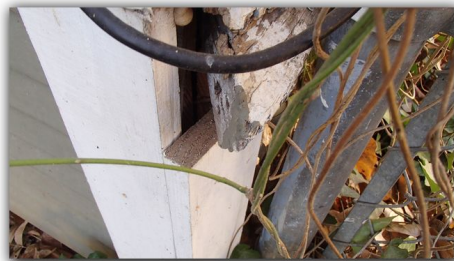
The wood siding and trim was observed to be damaged or deteriorated at the north, east, west, and south sides of the house, particularly along the lower edges of the siding. Repair is recommended.

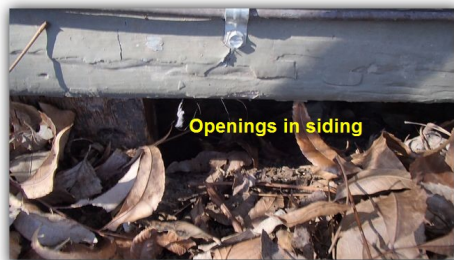
There were openings in the exterior veneer in various locations including at the north and east sides of the house that need to be sealed to prevent water or pest intrusion into the crawlspace.

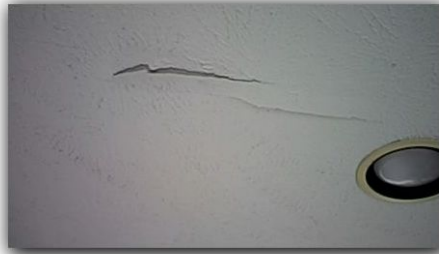
Ceiling texture was observed to be damaged in the carport. Repair is recommended.

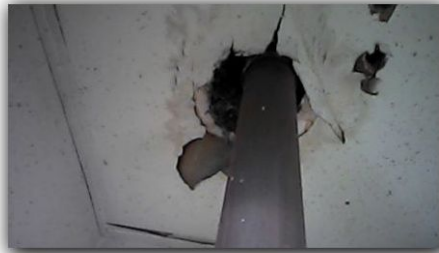
Water stains were observed at or around the water heater flue in the garage. The cause and remedy should be further evaluated and corrected as necessary.

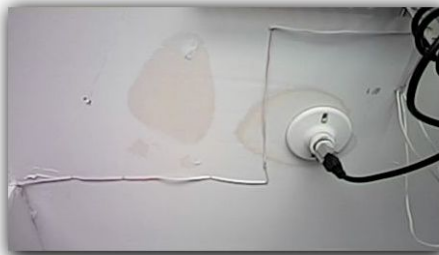
Water stains were observed on the ceiling finish in the garage in the northeast corner bedroom. The cause and remedy should be further evaluated and corrected as necessary.

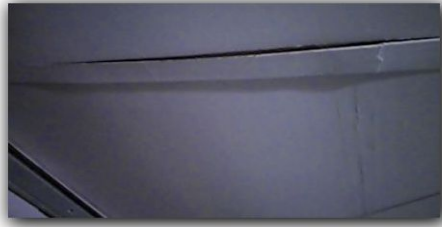
The ceiling of the attached garage adjacent to the living space was not fire taped at the joints or the fire taping is damaged or failing. Drywall cladding on garage ceilings and walls that are adjacent or common with the living space should have the joints taped and sealed to provide the required fire rating for attached garages.

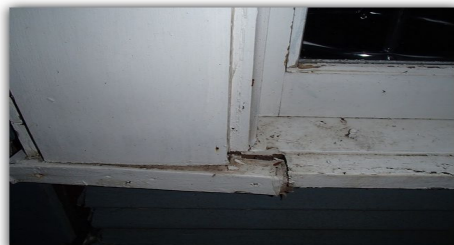
The trim was observed to be damaged or deteriorated on the windows at the north side of the house. Repair is recommended.

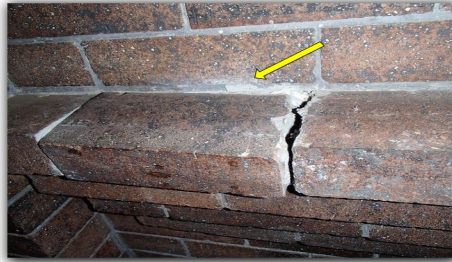
The fireplace firebox was observed to be cracked and damaged. Repair and mortar improvements are

The façade and mantle area of the fireplace was damaged. Repair is recommended.

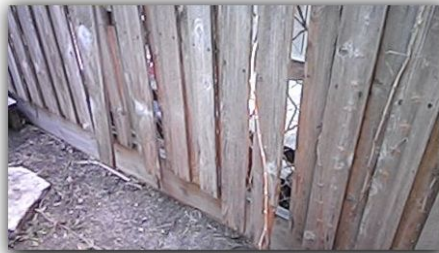
The wood fence was weathered and had numerous damaged or loose boards. Repair is recommended.

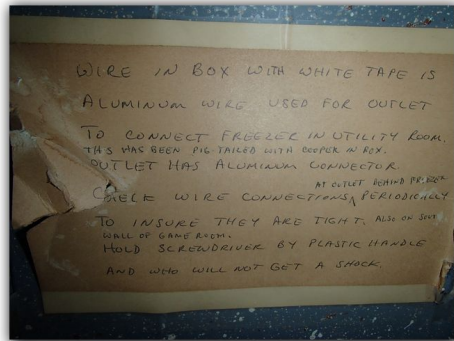
One aluminum wire circuit was present. Aluminum wiring requires special connectors. A note was present on the panel box cover stating that the appropriate connectors were in use, but this could not be verified. If concerns exist, further evaluation by a licensed electrician is recommended.

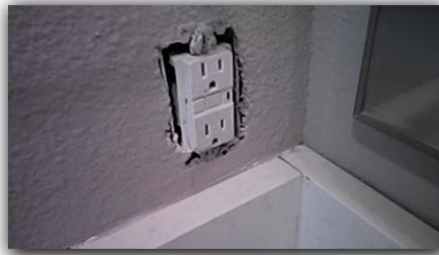
One or more of the receptacles is missing its cover plate in the half bathroom. Replacement of the cover plate is recommended.

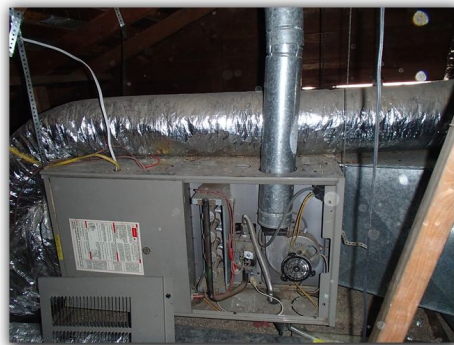
The heating equipment appears to have reached the end of its serviceable life expectancy.

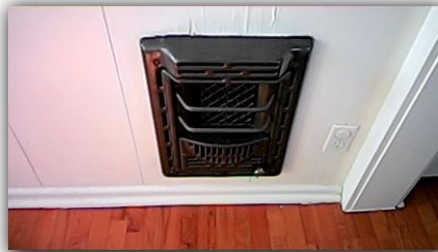
Unvented gas space heaters are present in the mudroom. Due to safety concerns, removal or replacement with a vented heater is recommended.

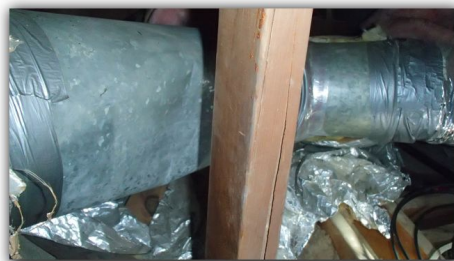
The covering on the ductwork that secures the insulation has deteriorated and the insulation is falling off in places, reducing the HVAC system efficiency. Repair or replacement of the damaged ductwork is recommended.

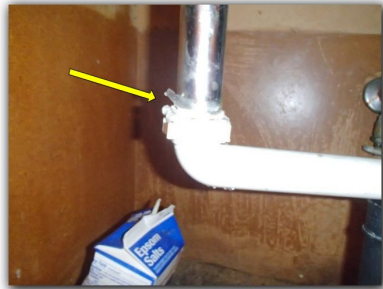
The sink was observed to have a leak at the drain in the kitchen. Repair is recommended.

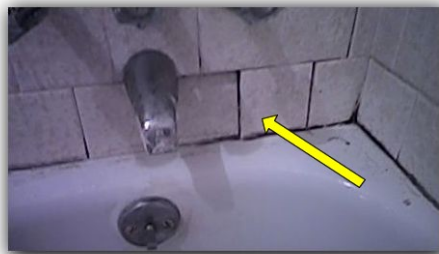
Damaged or missing tiles were observed in the shower stall in the shared bathroom. Repair is recommended.

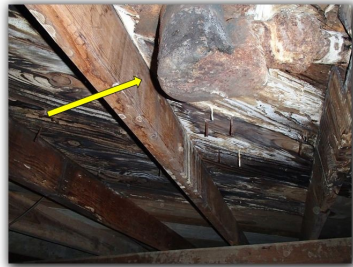
An older lead drum trap was observed under the shower in the hall bathroom. Replacement is recommended.

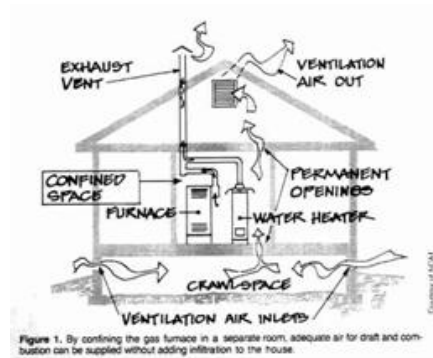
There is inadequate combustion air in the equipment closet. Combustion air for gas equipment should be supplied from an exterior source and not taken from the interior living space. Two metal pipes should be installed in the closet from the attic; one terminates near the ceiling and the other 12” from the floor to supply an outside air source.

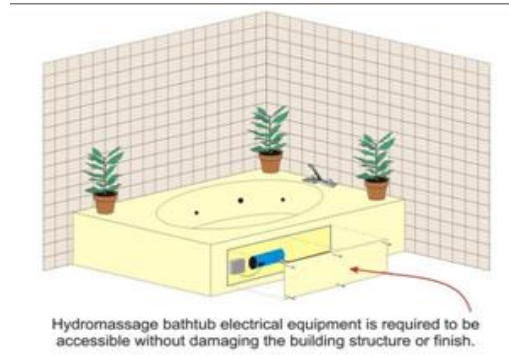
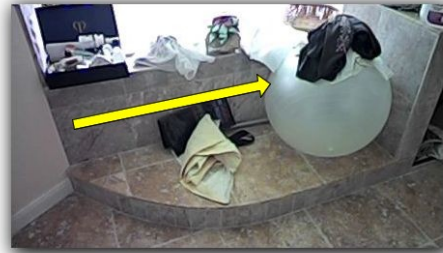
Although there is an access panel at the plumbing connections, the access to the hydro-massage therapy equipment motor and associated plumbing was not readily accessible and could not be visually inspected for proper configuration or leaks. This does not meet current installation standards.

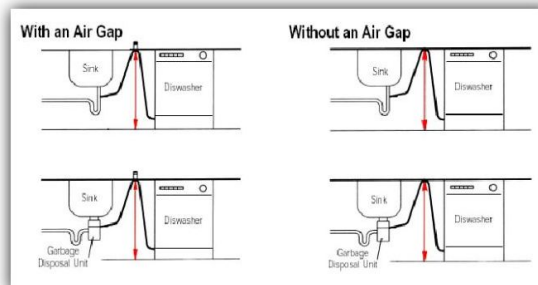
The dishwasher drain hose is not properly installed to prevent back flow or anti-siphoning. It is recommended that an air gap device or high drain loop be installed in the drain line. Note: Almost all dishwashers may have built in anti-syphon devices.

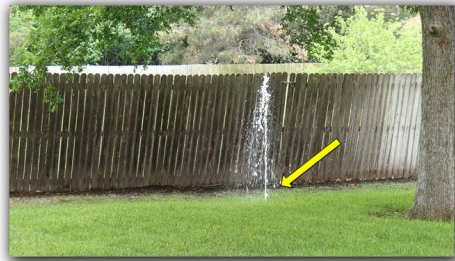
One or more sprinkler heads were damaged or missing in station 4 in the back yard. Repair is recommended.

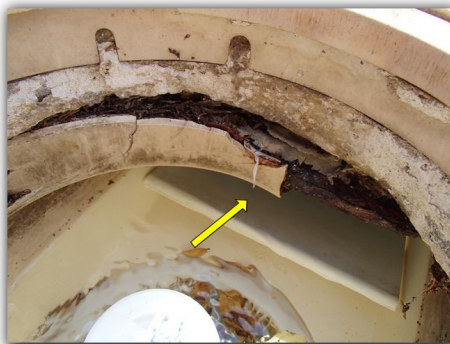
The skimmer basket housing was damaged and needs repair to prevent water intrusion and damage to the decking and pool.

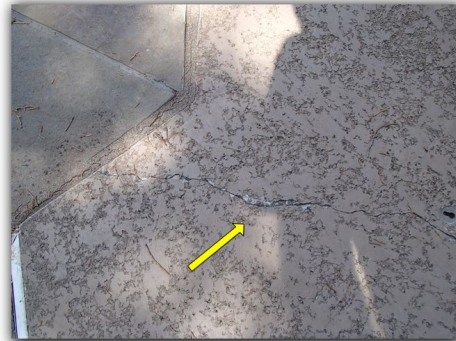
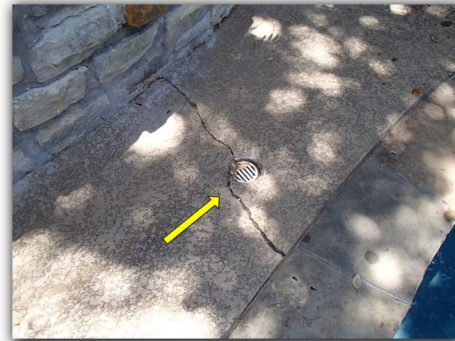
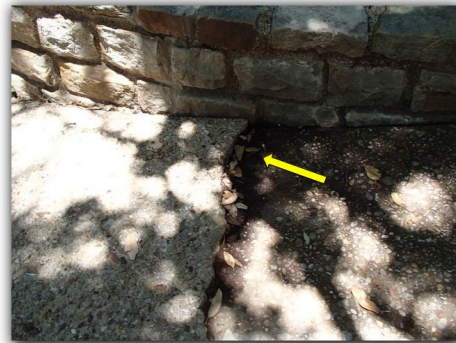
The deck was observed to be cracked or damaged and somewhat settled at the northwest corner of the pool. Repair is recommended.
