PROPERTY INSPECTION REPORT

Prepared For: John & Jill Doe
(Name of Client)

Concerning: 123 Sample Street, Dallas, TX 75000
(Address or Other Identification of Inspected Property)

By: Jay Wilkinson, Lic #TREC #20338 01/01/2019
(Name and License Number of Inspector) (Date)

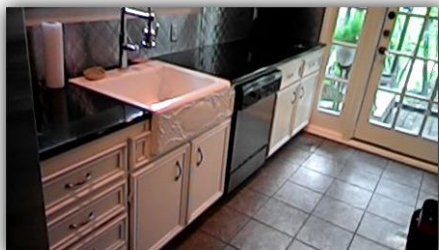
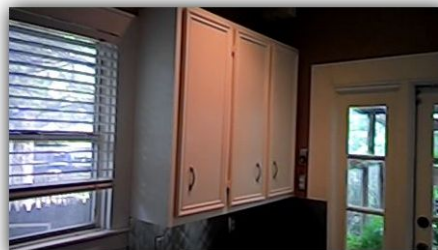
A door was misaligned due to a loose hinge in the cabinets in the kitchen.

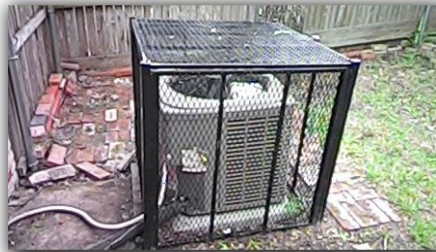
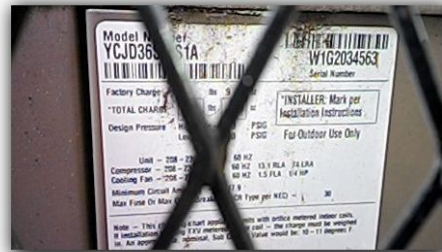
There is no secondary drain for the air conditioning coil. If piping a secondary drain line to the exterior is impractical, installation of a condensate overflow switch or alarm is recommended to avoid damage from obstructed primary condensate lines.

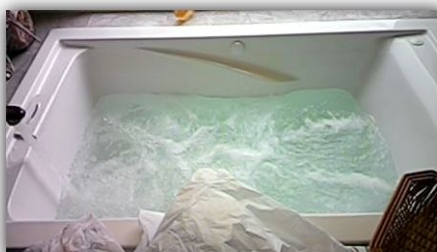
Operation of the GFCI breaker was verified in the master bathroom closet.

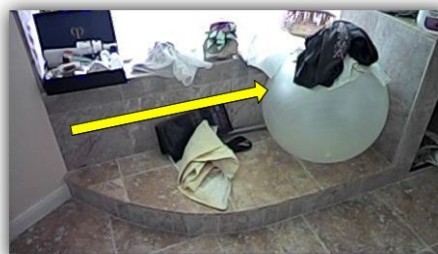
Although there is an access panel at the plumbing connections, the access to the hydro-massage therapy equipment motor and associated plumbing was not readily accessible and could not be visually inspected for proper configuration or leaks. This does not meet current installation standards.

Hydromassage bathtub electrical equipment is required to be accessible without damaging the building structure or finish.
