# armor home inspections

**Jill Doe**  
**123 Sample Street**

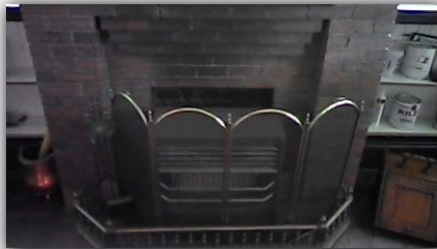
*Type and location:* Decorative fireplace only, in the living room

The fireplace was decorative only, not intended for use as a wood burning fireplace without repair.

The fireplace firebox was observed to be cracked and damaged. Repair and mortar improvements are recommended.

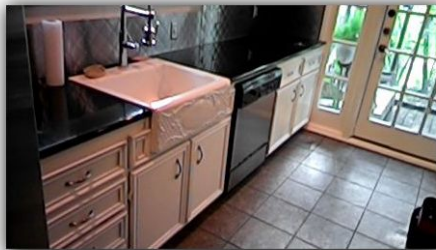
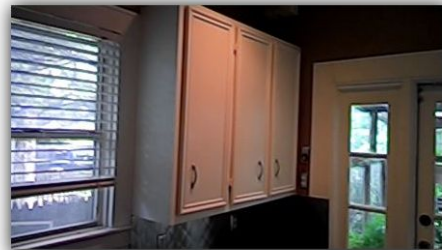
A door was misaligned due to a loose hinge in the cabinets in the kitchen .

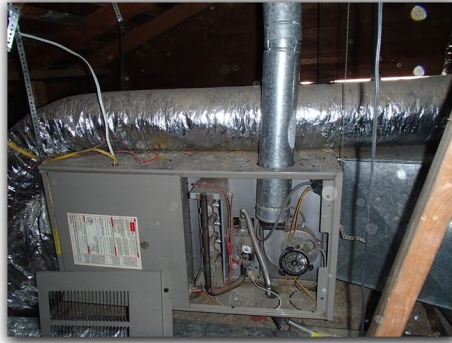
**Central Heating System** – *Energy Source:* Natural gas, Goodman, 1997

**The heating equipment appears to have reached the end of its serviceable life expectancy.**

Although the heating system components may be functioning as intended or in need of minor repairs, you should be aware that these are older components and the future life expectancy cannot be determined. You can continue to use and service these components until replacement is necessary.

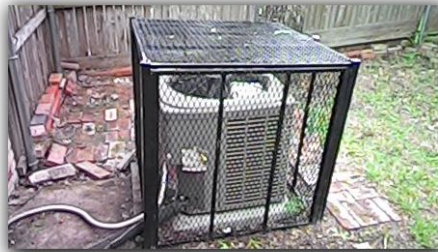
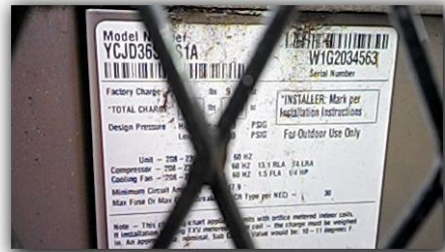
There is no secondary drain for the air conditioning coil. If piping a secondary drain line to the exterior is impractical, installation of a condensate overflow switch or alarm is recommended to avoid damage from obstructed primary condensate lines.

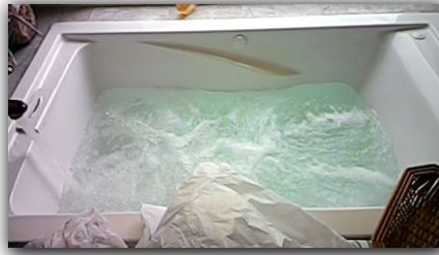
Operation of the GFCI breaker was verified in the master bathroom closet.

Although there is an access panel at the plumbing connections, the access to the hydro-massage therapy equipment motor and associated plumbing was not readily accessible and could not be visually inspected for proper configuration or leaks. This does not meet current installation standards.

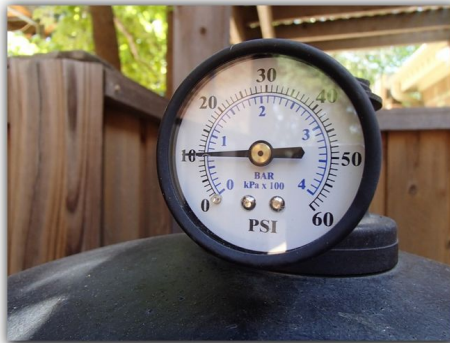
Visible deficiencies were observed in the pool finished surface. Some resurfacing may be necessary. This condition should be further evaluated by a professional pool service.

Visible deficiencies were observed in the spa finished surface. Some resurfacing may be necessary. This condition should be further evaluated by a professional pool service.
