armor home inspections

PROPERTY INSPECTION REPORT FORM

Jill Doe <i>Name of Client</i>	04/24/2024 <i>Date of Inspection</i>
1234 Sample Street, Dallas, TX 75111 <i>Address of Inspected Property</i>	
Jay Wilkinson <i>Name of Inspector</i>	TREC #20338 <i>TREC License #20338</i>

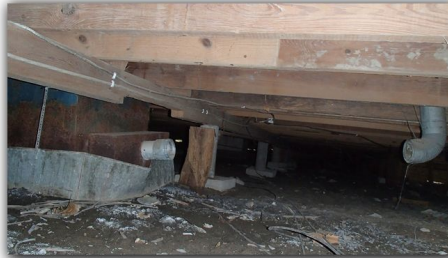
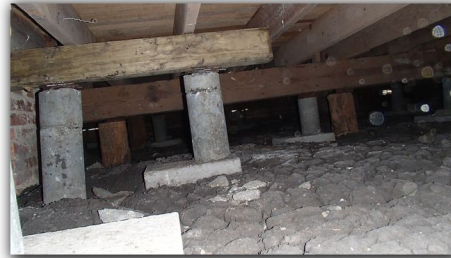
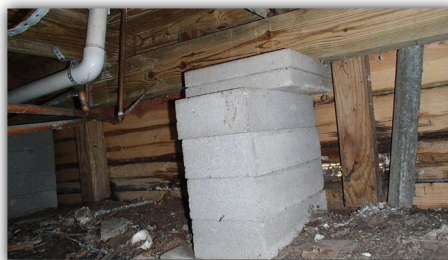
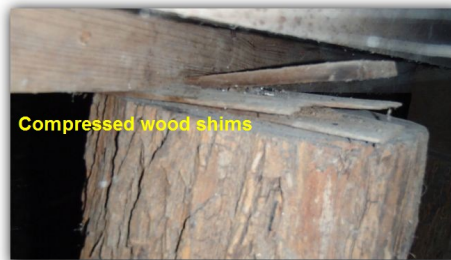
Crawlspace views:

One or more of the piers have shifted somewhat, as is typical of many houses due to expansive soils in the North Texas area. These should be monitored periodically.

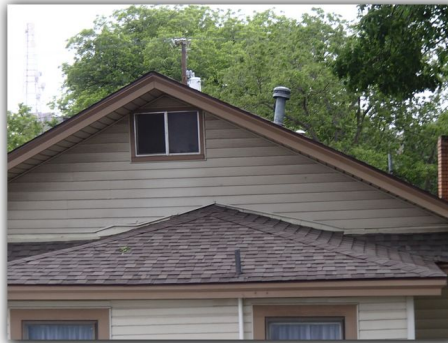
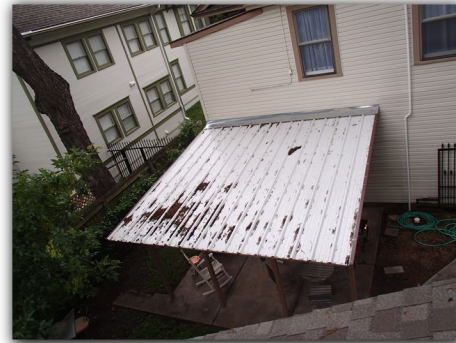
Roof views:

Roof fasteners (nails and/or staples) were observed to be exposed on various locations of the roof including the ridge caps and flashing areas. All exposed fasteners should be sealed with the appropriate roofing caulk or sealant.

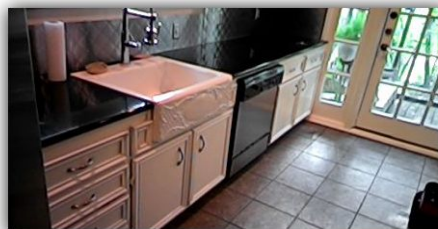
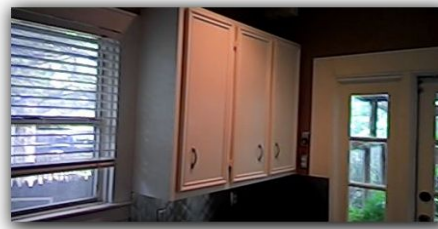
The cabinets were achieving an operation and function that was consistent with accepted industry practices for their age.

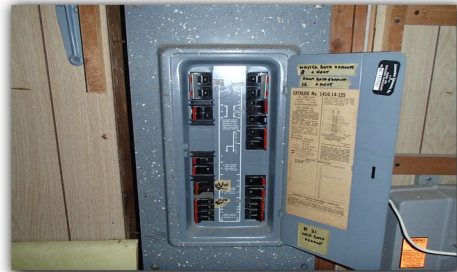
Box Rating and/or Main Disconnect Rating: 125 Amps , Federal Pacific

Box Location: Master Bedroom Clothes Closet

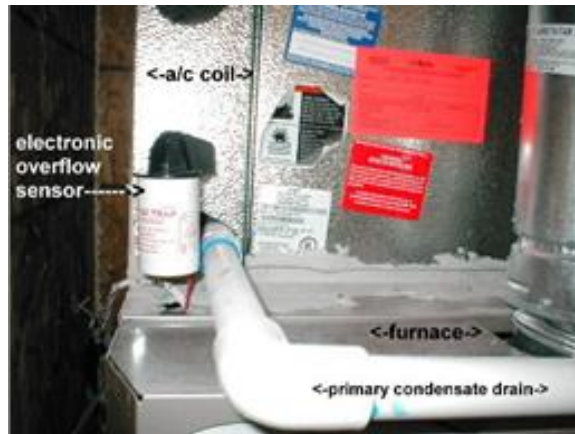
There is no secondary drain for the air conditioning coil. If piping a secondary drain line to the exterior is impractical, installation of a condensate overflow switch or alarm is recommended to avoid damage from obstructed primary condensate lines.

Example photo of an overflow switch

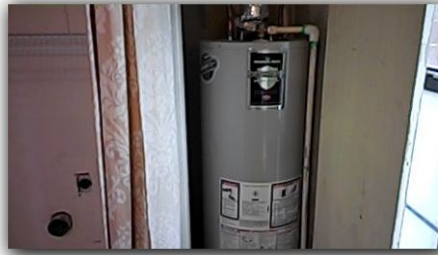
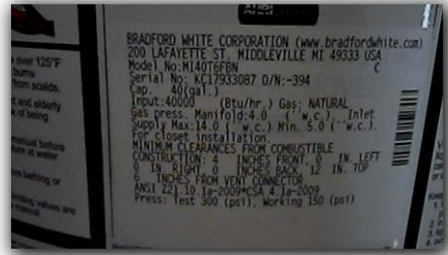
The equipment closet door should be sealed on all sides to prevent any combustion fumes or gas from entering the living space.

All or part of the vent piping was observed to be single wall pipe at the water heater. Current building practices call for double wall pipe (B-Vent) for the entire run of the vent piping. Repair is recommended.

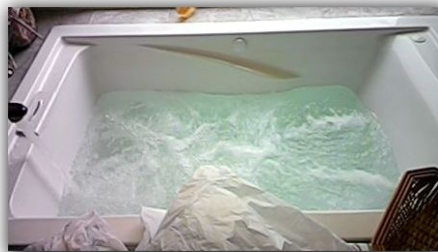
The hydro-tub in the master bathroom was filled with water and observed in operation for approximately ten minutes. This component appeared to be performing consistently with accepted industry practices for its age at the time of this inspection.

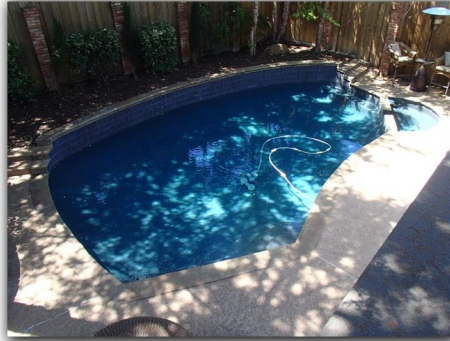
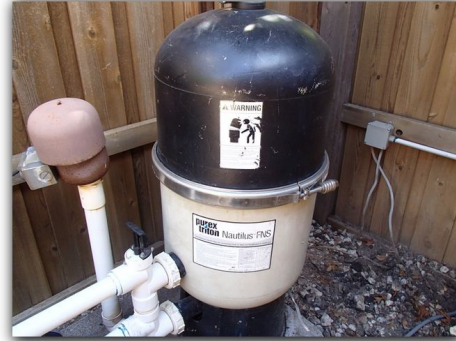
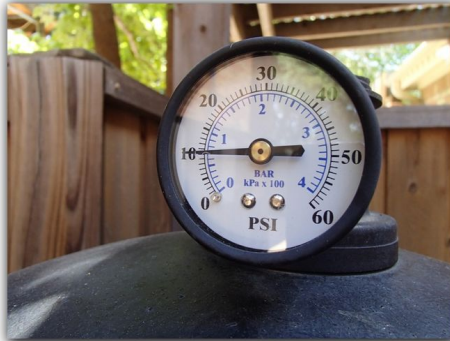
Visible deficiencies were observed in the pool finished surface. Some resurfacing may be necessary. This condition should be further evaluated by a professional pool service.

Visible deficiencies were observed in the spa finished surface. Some resurfacing may be necessary. This condition should be further evaluated by a professional pool service.
